# Community Hospital Torrington, Wyoming

## Essential Electrical System Power Quality Issues

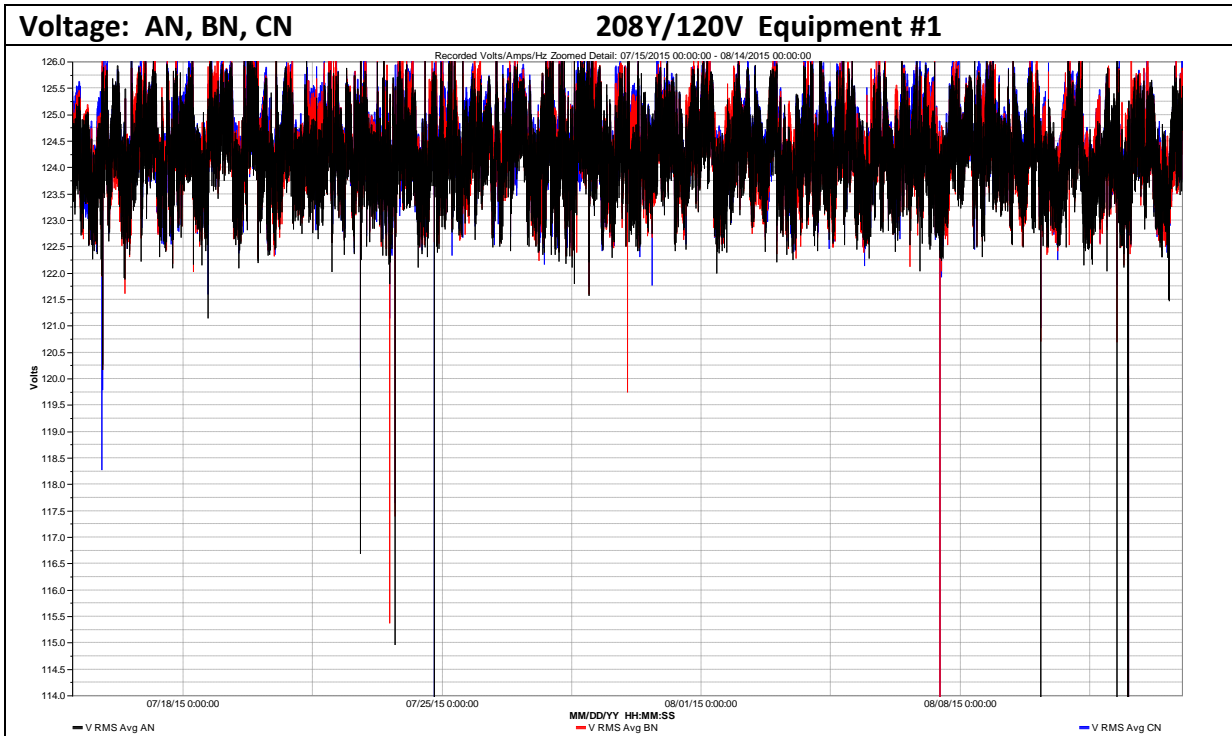
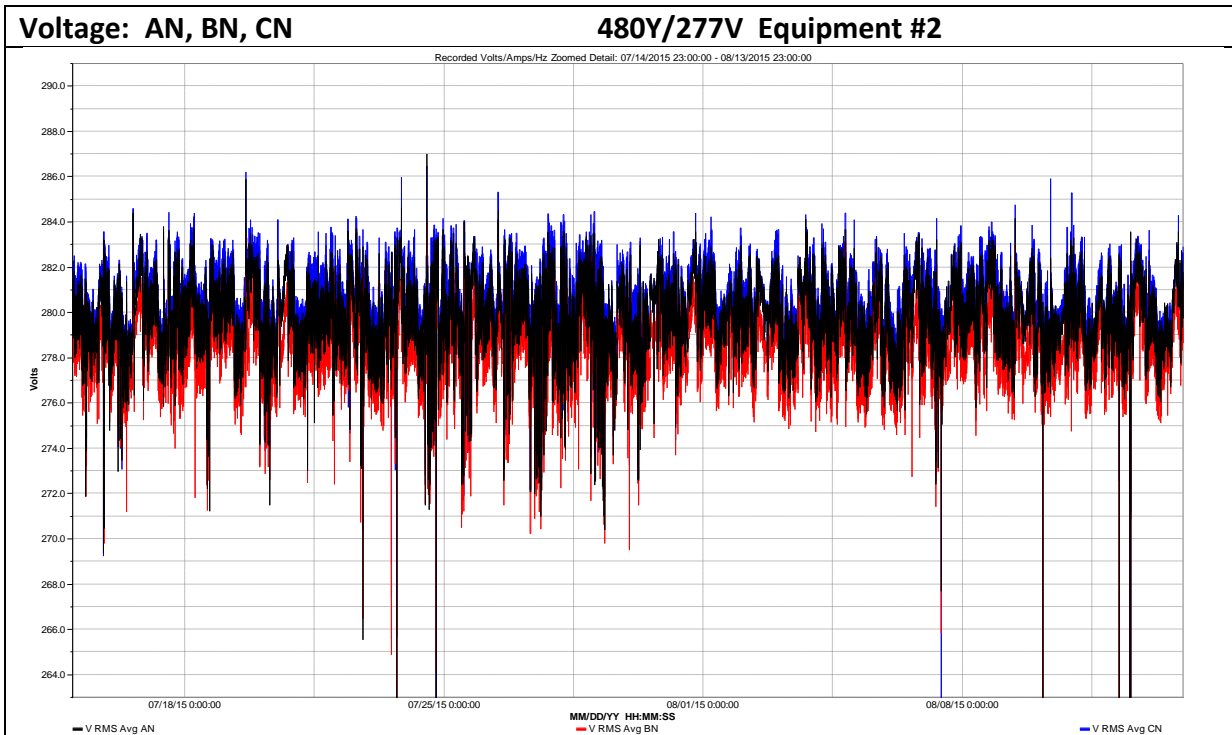
Normal power supplied by the City of Torrington Utilities Department is well-regulated with respect to voltage range for the 480Y/277V service. However, the 208Y/120V service voltage is at the top of the required  $\pm 5\%$  range. Refer to data graphs on next page.

Sustained overvoltage – even when sustained at  $+5\%$  – contributes to premature failure of sensitive electronic equipment components, lighting ballasts, and lamps. The additional benefit to lowering the normal 208Y/120V voltage is that it will more closely match the output voltage of the 500 kVA, 480V:208Y/120V transformer supplying standby generator power to essential electrical system loads, making for smoother load transfers.

The two graphs that follow provide a representative sample of the two utility services, each within its respective phase-to-neutral voltage displayed in a  $\pm 5\%$  window.

Approach the City of Torrington Utilities Department about “bucking” (lowering) the 208Y/120V voltage. The voltage regulators located at the SE corner of Community Hospital allow for small adjustment increments; however, these regulators probably effect change in both the 480Y/277V service and the 208Y/120V service. Since no change is recommended for the 480Y/277V service voltage, a tap-change to “buck” the 208Y/120V utility service transformer voltage is the more likely avenue for lowering the normal voltage so that it is more centered in the 120V  $\pm 5\%$  window. Refer to data graph on the next page.

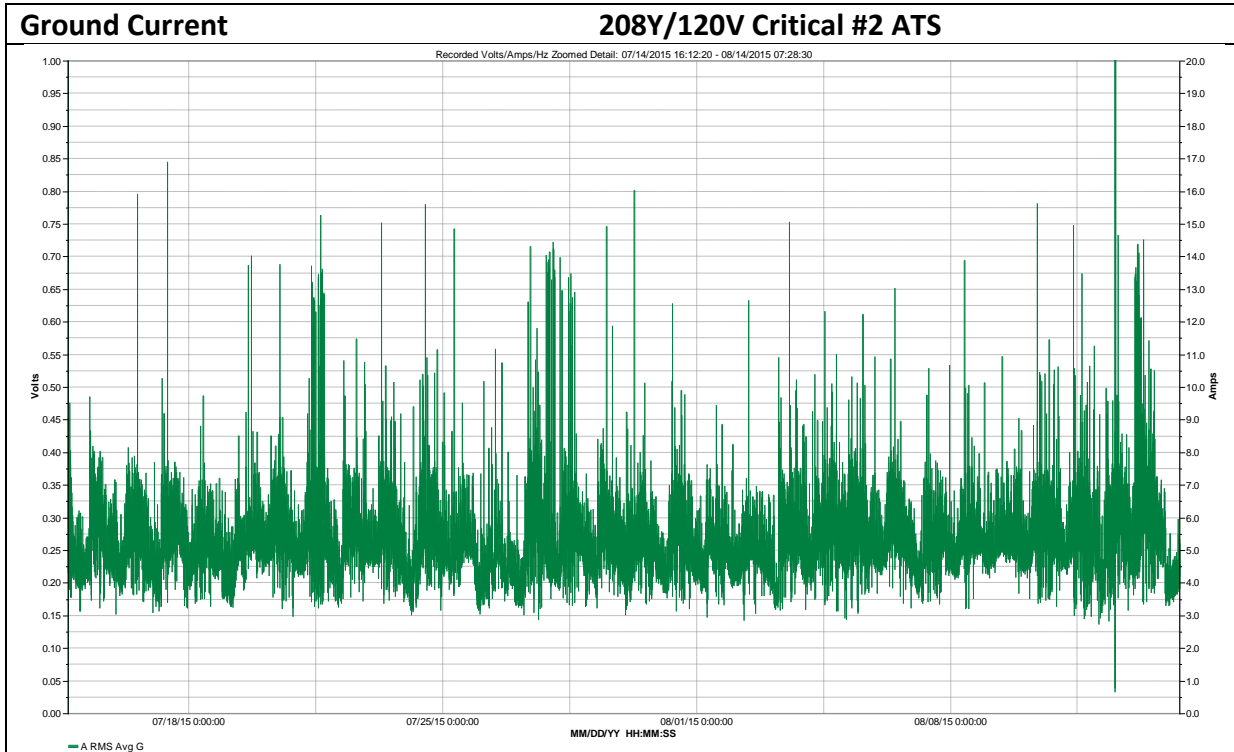
Objectionable ground currents are present, with those recorded at the 208Y/120V “Critical #2” ATS particularly significant.

Large amounts of current flow on ground can adversely affect equipment and trigger ground fault circuitry. The ground current level indicates the likelihood of wiring errors in the distribution network supplied by the “Critical #2” ATS. Two common wiring errors are:

1. Improper connection of neutral conductor to ground conductor permits neutral currents to flow in the grounding system.
2. Improper use of the ground in cases where a neutral is required, but not readily available. Example: It is an all too common practice for mechanical systems tradesmen to use phase-to-ground when installing a 120V receptacle alongside 3-phase 208V mechanical equipment.

Have *Power Quality Specialists* inspect the “Critical #2” switchboard and eleven (11) branch circuit panelboards that it feeds to identify potential sources for ground currents. Have *Pittman Electric* provide inspection support as needed, as well as perform the necessary work to correct identified wiring errors.
